VEE LINE

NUMBER 80

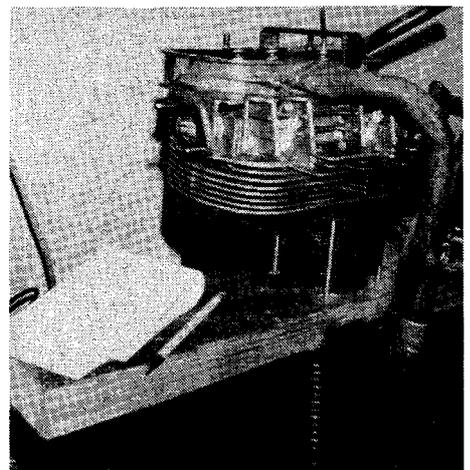
Close-up of the business end of the flow tester. More on this next time.

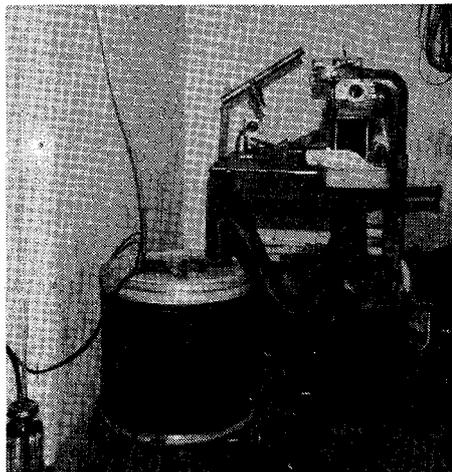
Pore-boy flow tester. The gadget on the back of the bench is a valve spring compressor.

Our manifold drew 17½ inches of water on one side, and 18 on the other, in stock condition. The vertical downtube is furnace-brazed to the horizontal tube, and since Walter Striedieck (in the January issue) cautioned against the inclusion of any copper in the etching process, it seemed a good idea to melt that joint apart, clean off all traces of the brazing metal and then gas-weld it back together again. At the same time, it also seemed a good idea to enlarge the hole in the horizontal tube and bevel the edges in order to insure a smooth transition after the etching process. The brass was removed with the rotary file used for porting, the joint was welded back together, and the manifold was tested again. This time—both sides tested the same, at 17¼ inches. There was no clue as to why the "bad" side was improved more than the good one, but it definitely was.

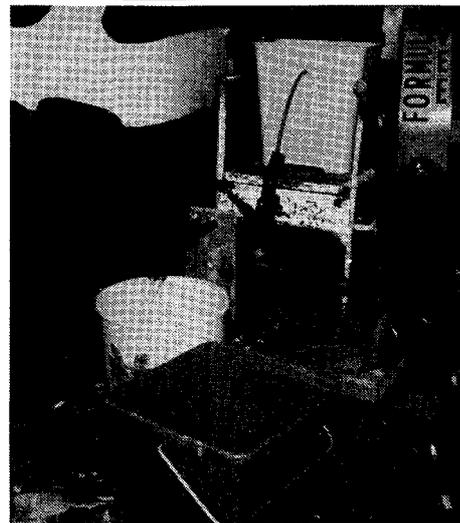
This is the Manifold Etching Division. Petunia on her trailer in the background.

Holes were cut in the previously mentioned multi-purpose plank to fit the manifold and rubber tire valve stems (with the brass valve mechanism drilled out) were used as gaskets, with the stems protruding down through the holes. A length of plastic tubing was slipped over each one and was led up through holes drilled in a board which held the ends somewhat higher than the carburetor flange on the manifold. (The manifold was bolted to the board in the normal position, using carriage bolts.) The neck of an old manifold was cut to about four inches long and was bolted to the carburetor flange to act as an extension, so the fluid could be carried at a level high enough to submerge the entire inner surface. A hole was drilled in the side of a waste basket, about three inches below the top, of a size to fit snugly around the plastic tube used as the siphon. When the container is filled above that level the siphon is self-starting. (You wouldn't want to suck on it to start *that* stuff!) An outlet in the bottom would

serve just as well, except that a leak would be somewhat embarrassing. The system was tested with plain water first, then with a strong lye solution which was left to soak overnight after I got tired of playing with it.
